ST LUKE'S WEST HOLLOWAY
LONDON N7 9JE

SOUTH AISLE
SUMMARY CONDITION REPORT

18th February 2021

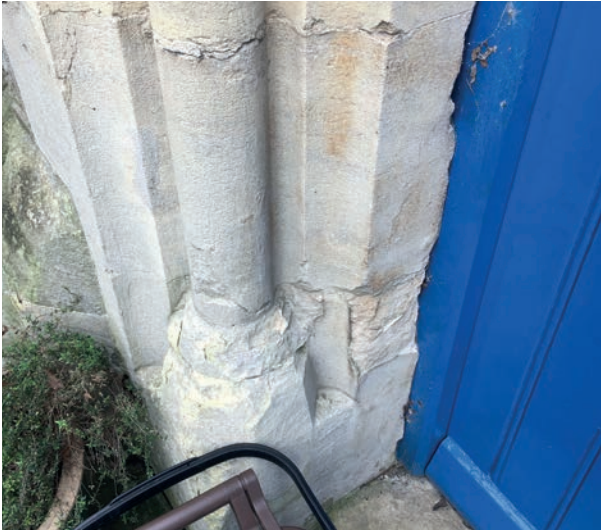
- 1.4** A number of stones have decayed to such an extent that up to 100mm of the surface has been lost. requiring complete replacement of particular stones. This is particularly prevalent at low level.

a.
Erosion of stonework at low level - south porch.

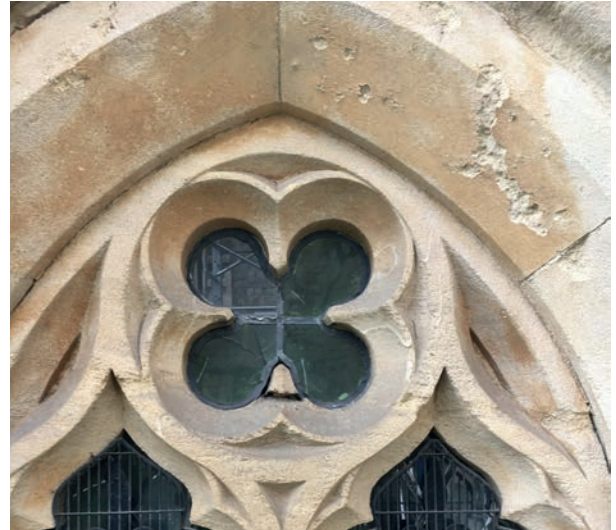
b.
Fractured stonework at quatrefoil window - east elevation of south porch.

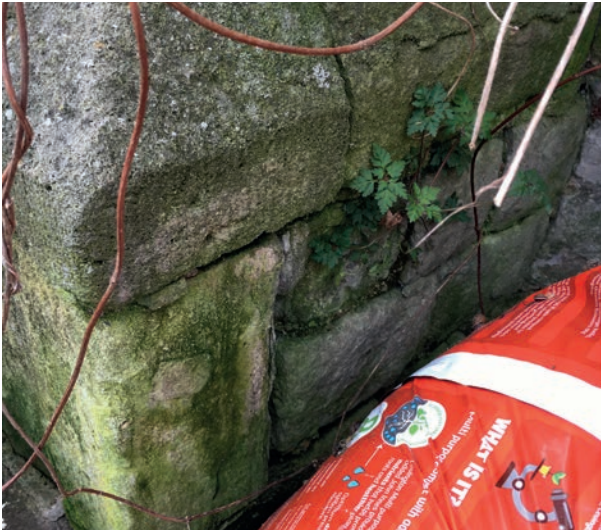
c.
Typical deterioration of stonework at plinth.

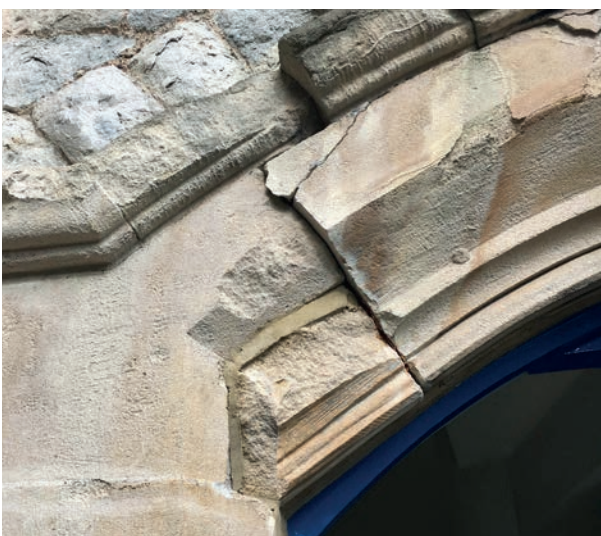
e.
Erosion of hood moulding and fractures to stonework at turret door head.

- 1.13** Dowel repairs are required to fractured stonework at the turret door.
- 1.14** The turret roof is formed of stone slabs which have delaminated at the surface and which have open joints between stone units. This will require a total defrass, removal of sand & cement pointing and repointing. The apex stone will require replacement.

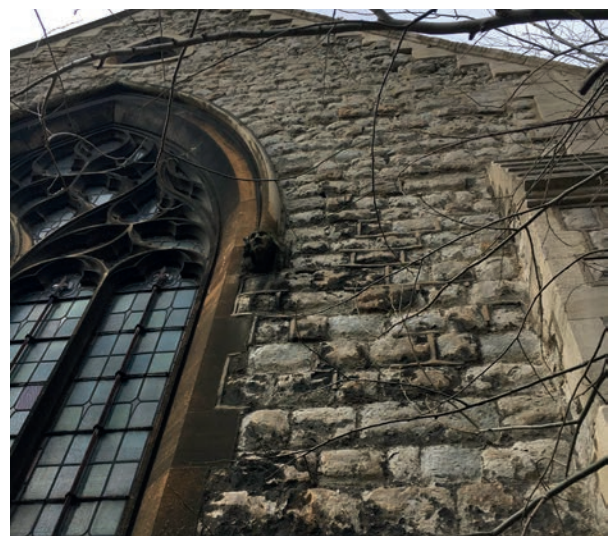
- 1.8** The south transept is covered in ivy, which is damaging the pointing and should be removed.
- 1.9** Conservation cleaning of the south transept should be carried out prior to any stonework repairs.

f.
Overview of south transept elevation.

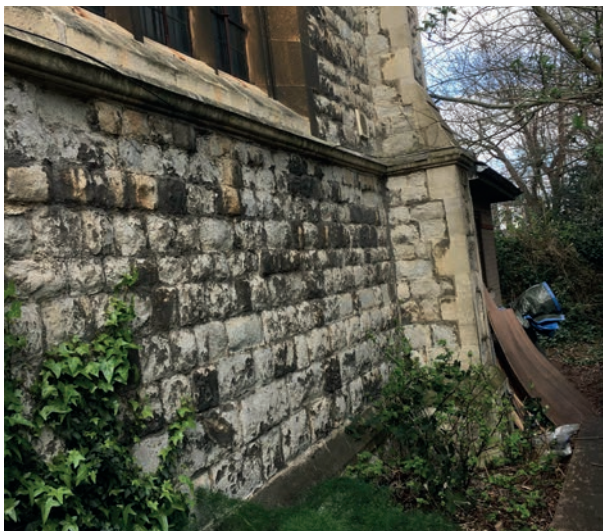
g.
South transept elevation - low level.

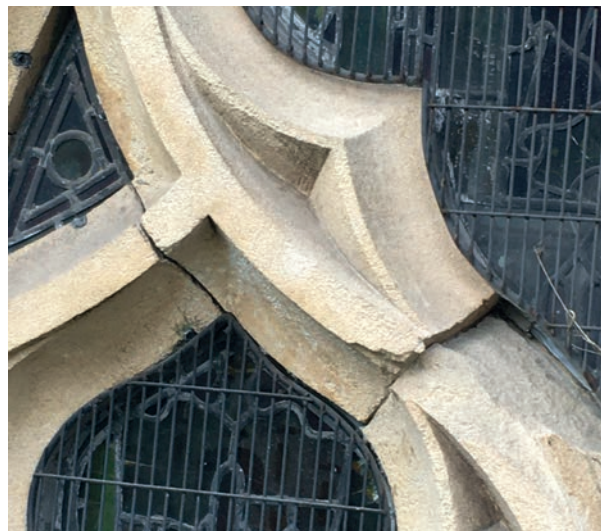
h.
Fractures through south aisle tracery.

- 1.11** Window tracery is also in Bath Stone and has suffered some decay at hood mouldings which require a number of small stone indents.
- 1.12** Some fracturing of window tracery has occurred at the mullions, requiring indents to the profiled sections.

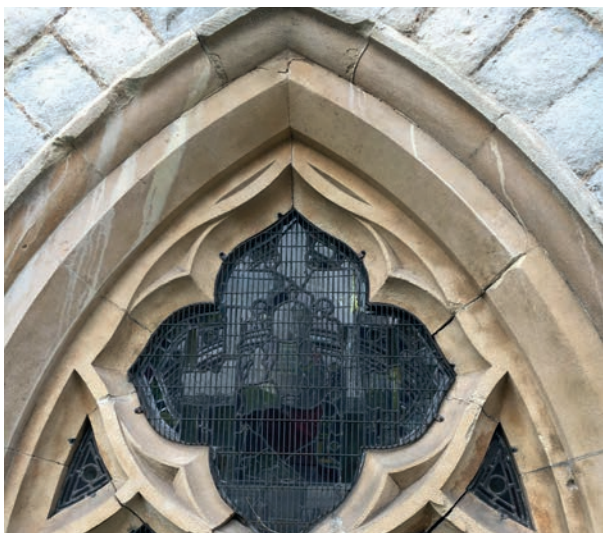
j.
Open joints and eroded hood moulding - south aisle window surround.

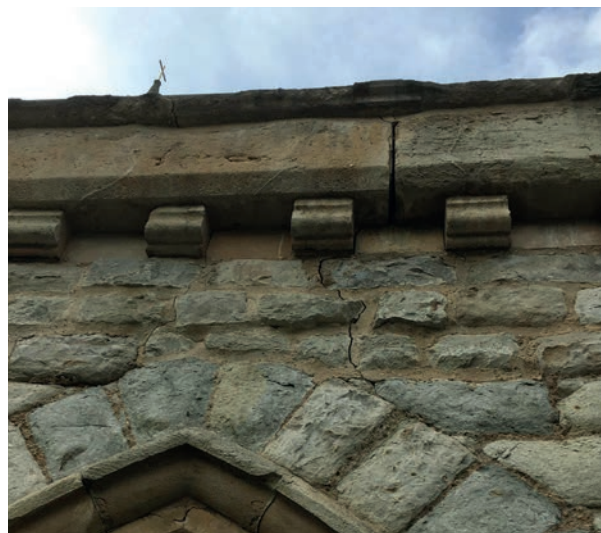
- 1.6** A light defrass is required in a number of locations where the surface of the Kentish Ragstone has become loose or friable.
- 1.7** There is some evidence of movement within the south aisle stonework as a whole, but this is not thought to be ongoing. This is particularly evident above the arched window heads. Repointing is required to deep cracks in these locations. Once pointing is complete, longer term monitoring should be carried out in order to confirm this is not an ongoing issue. These cracks extent through the parapet stones, which should also be repointed.

k.
Typical cracking through parapet stonework above south aisle window heads.

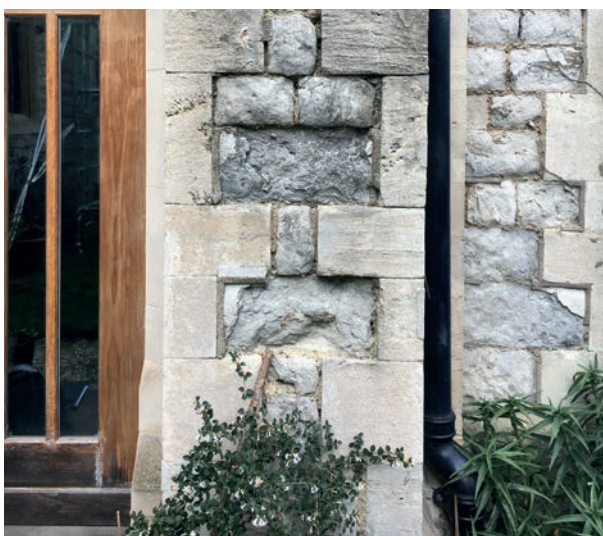
l.
Typical erosion of Kentish Ragstone at buttresses.

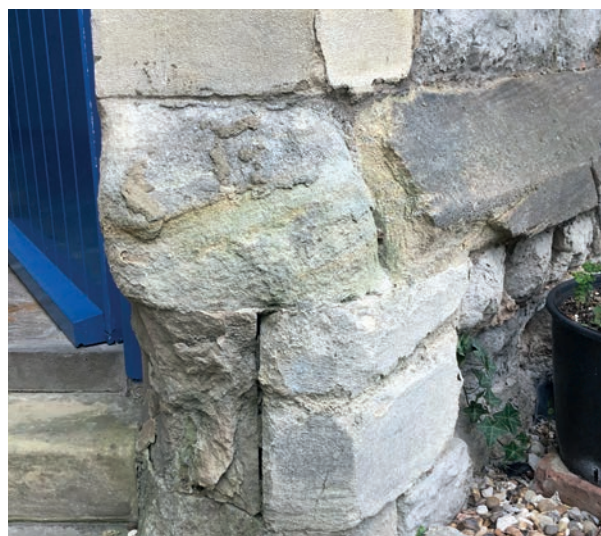
m.
Erosion of stonework at low level adjacent to turret door.

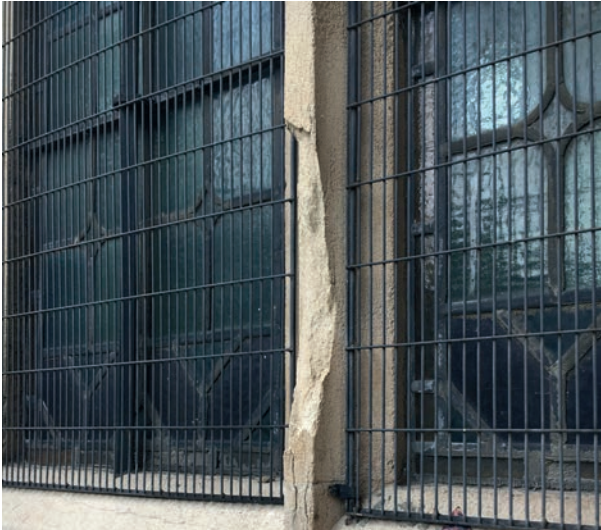
n.
Spalled stonework to window mullion - south aisle.

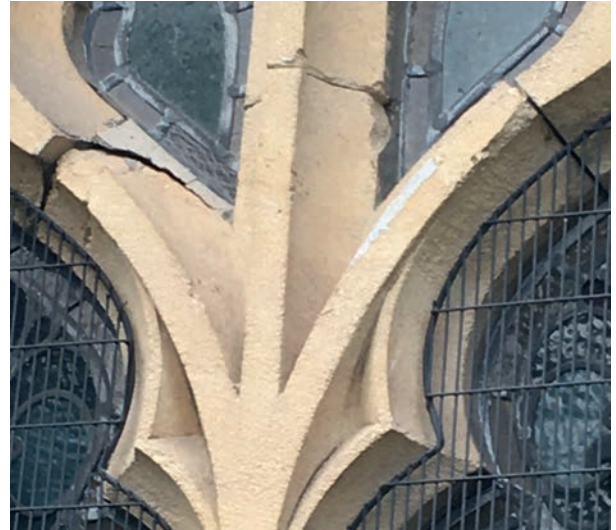
p.
Previous mortar repairs to tracery - south aisle.

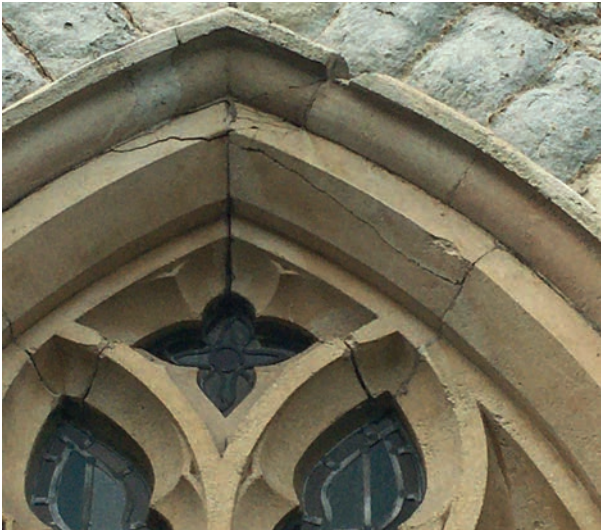
q.
Cracking across stonework to window surround - south aisle.

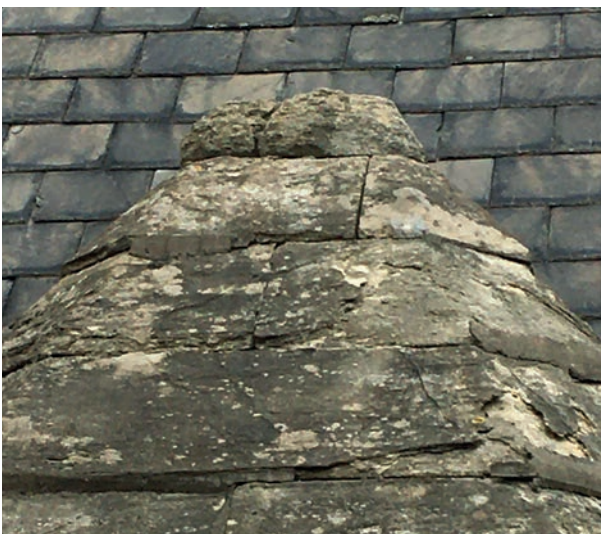
s.
Erosion of turret roof apex stone.

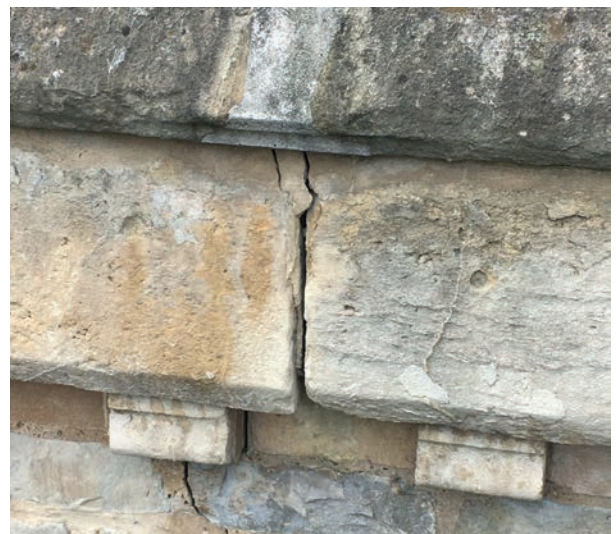
t.
Open joints to turret roof corbel.

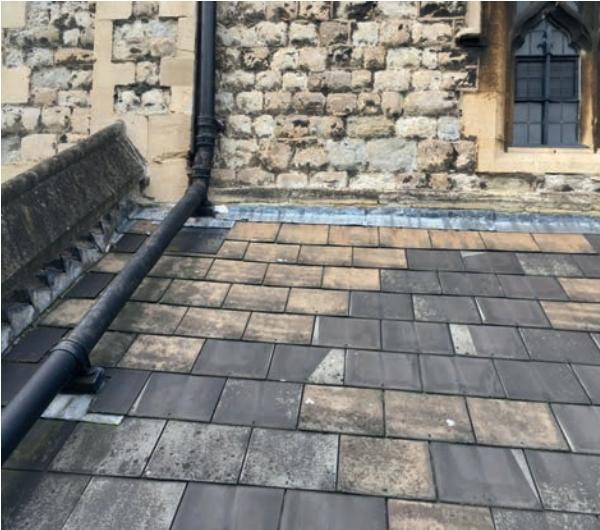
- 2.5** The roof is covered in artificial fibre-cement slates, areas of which have been patched at various times.
- 2.6** There are a number of broken or slipped slates and the oldest examples are warping and starting to lift.

- 2.7** Patches are evident to the areas below the rainwater pipes from the nave roof, which would suggest a previous problem where one roof discharges water onto the other and indicates that the rainwater pipes following the pitch of the roof are a relatively recent addition.

U.
West end showing RWP from nave roof crossing aisle roof and slipped/damaged slates.

- 2.11** To maintain the height of the existing flashings at the abutment, a leadwork secret gutter will be introduced in this location.
- 2.12** The rainwater pipes crossing the aisle roof will be removed and lead spreaders will be introduced below the rainwater pipe locations in order to disburse the rainwater across the roof.

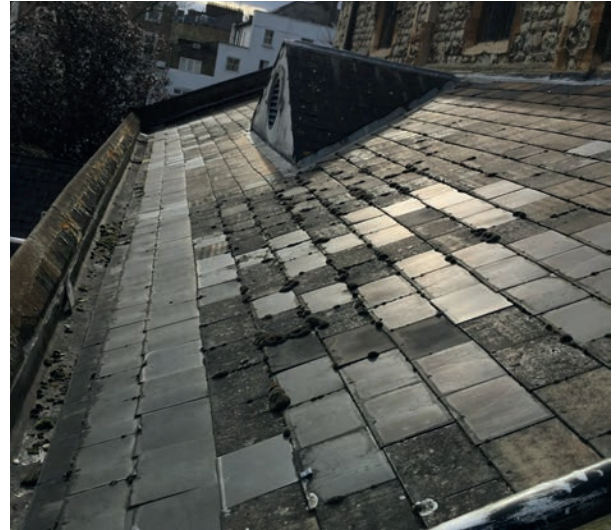
- 2.10** Leadwork generally is in reasonable condition, although the pointing above is defective in a number of locations. As introducing counter-battens into the roof build-up will increase the thickness and raise the roof pitch slightly, the flashings will all need to be relocated to a higher position which will involve introducing new chases into the stonework, and complete renewal of the lead flashings.

V.
View looking west showing defective flashings at parapet and redundant dormer.

- 2.4** There is a single dormer installed in the centre of the roof in the 1980s, thought to be serving no purpose, but installed to match a corresponding dormer on the north side containing extract vents from spaces below. The proposal is to remove this dormer as part of the re-roofing works in order to facilitate the installation of photovoltaic panels.

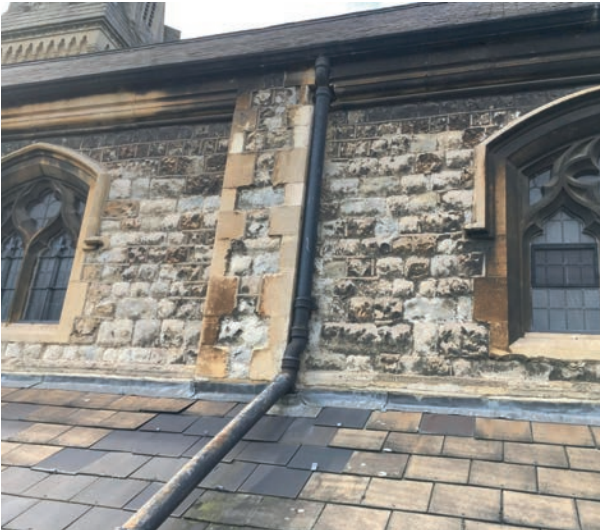
W.
Patches of defective slates with more recent patch repairs in fibre cement.

- 2.8** The proposal involves completely re-slating the south aisle roof in natural slate, to include the introduction of a TLX Gold insulation/breather membrane in order to improve thermal performance. This will also involve introducing counter-battens to introduce a void above and below the insulation.

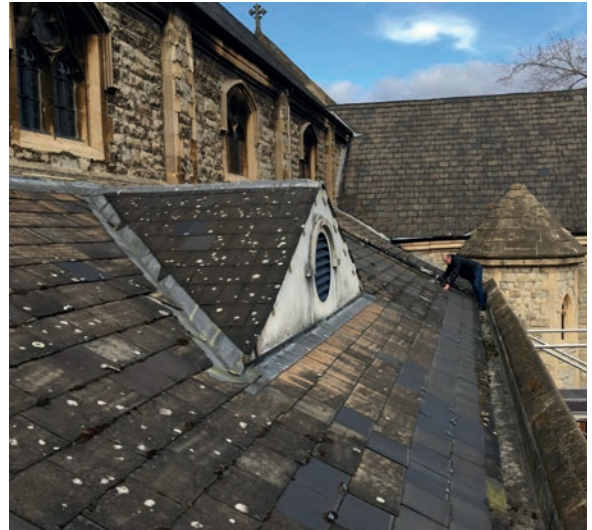
X.
View looking east showing existing asphalt gutter and replacement fibre cement slates at low level.

- 2.9** Dampness in the wall below the gutter, particularly at the west end, is not thought to be an ongoing issue but would suggest a previous problem with the gutter in this location. The proposal is to renew the gutter in lead as part of the roofing works.
